**CONSTRUCTION COST ESTIMATE  
BOROUGH OF BEACH HAVEN  
EMERGENCY OPERATIONS BUILDING REPAIRS AND IMPROVEMENTS**

**BOROUGH OF BEACH HAVEN  
NEW MUNICIPAL COMPLEX**

**EMERGENCY OPERATION CENTER  
Condition Study & Estimates**

**PROGRAM STUDY  
BEACH HAVEN MUNICIPAL BUILDING COMPLEX**

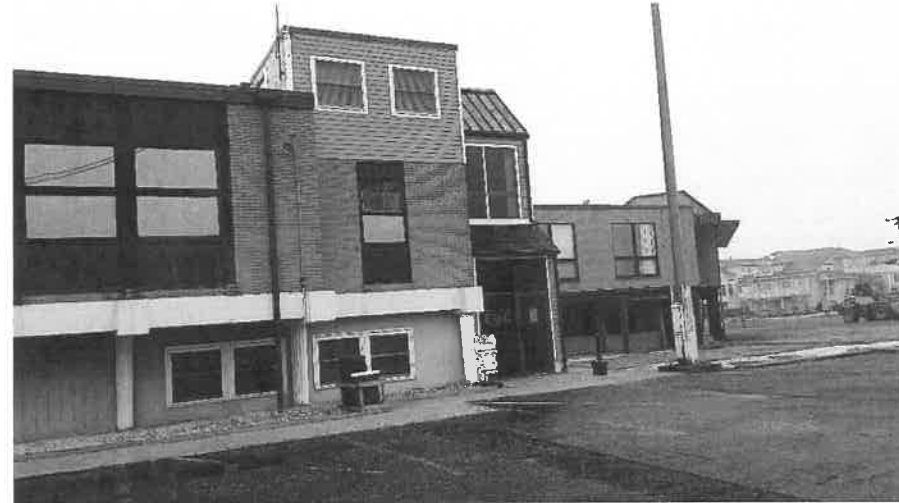
- **Entrances:** The main entrance to the building is not in compliance with accessibility requirements. The existing exterior landing area is greater than  $\frac{1}{2}$ " below the finish floor of the building. Changes in level along an accessible route may not exceed  $\frac{1}{4}$ " if abrupt or  $\frac{1}{2}$ " if beveled 1:2. The exterior concrete walkway at the main entrance will need to be reconstructed to provide for the maximum elevation differential.

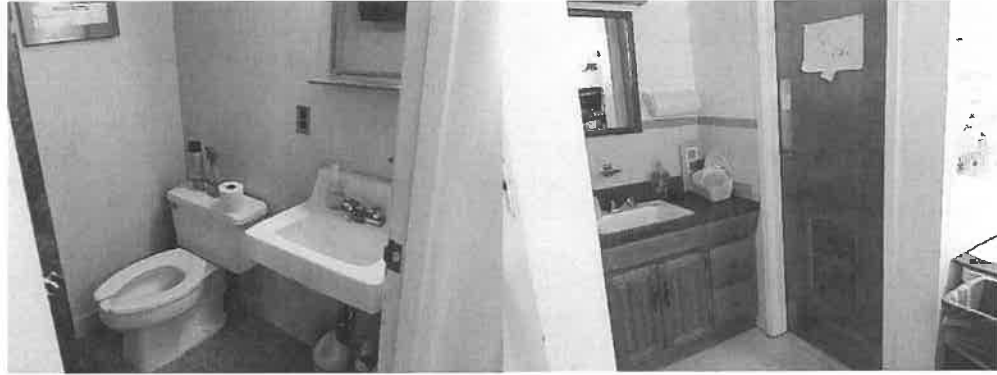
- **Toilet and Bathing Rooms:** There are no common area toilet rooms provided within the building. Individual single user toilet / shower rooms are provided throughout the existing offices and dormitory rooms. There is a single user toilet room located on the second floor within the area currently occupied as the Emergency Management Office. None of the existing toilet rooms or toilet / shower rooms are accessible. At a minimum, to comply with the requirements of the ADA, at least one accessible unisex toilet and bathing room must be provided. The room will need to be located in a common area.

If the building occupancy is to be changed, compliance with Plumbing Code requirements for common use toilet rooms with separate facilities for each sex may be required. If this is implemented, at least one of each type of fixture provided in each of the toilet rooms must be accessible.

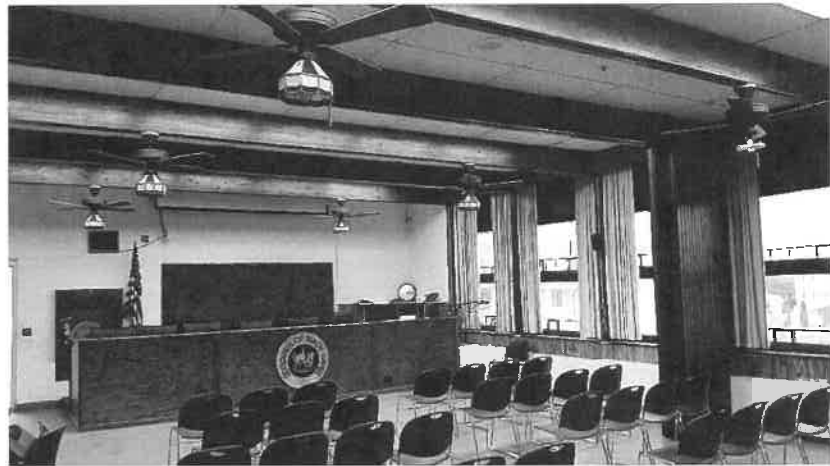
- **Exterior Doors:** Exterior exit doors require excessive force to open and close. The doors and/or hardware will need to be adjusted or replaced.
- **Interior Doors:** The majority of the existing interior doors are of sufficient width but are not equipped with lever handle hardware. Existing knob style latch and locksets should be replaced with lever handle hardware. Doors to walk in closets are less than the required clear opening width of 32" between the door in an open position and the frame stop and should be replaced with 32" wide doors.
- **Meeting Room Platform:** The raised platform at the Meeting Room is not accessible. The height of the platform is gymnasium stage is 6 1/2". A ramp is required to provide accessibility to the raised platform level. Because the rise is greater than 6" handrails will be required on both sides of the ramp.

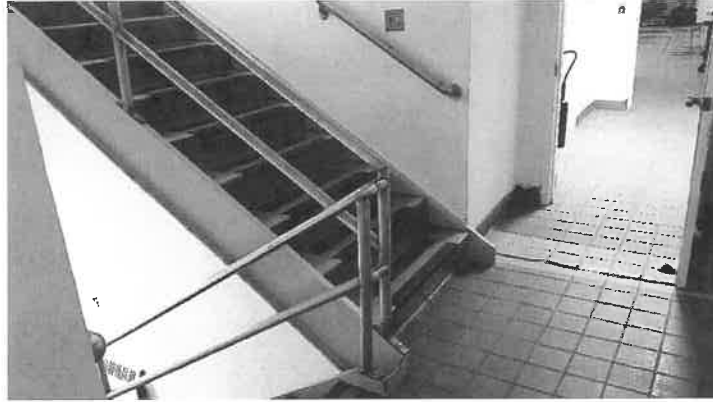
- **Existing Stair:** The existing stair connecting the entrance level to the lower, main, and upper levels, is in good condition and the width, riser, and tread dimensions are in compliance with ADA and Code requirements. The existing handrails do not comply with Code or ADA requirements with respect to extensions and will need to be replaced or modified.

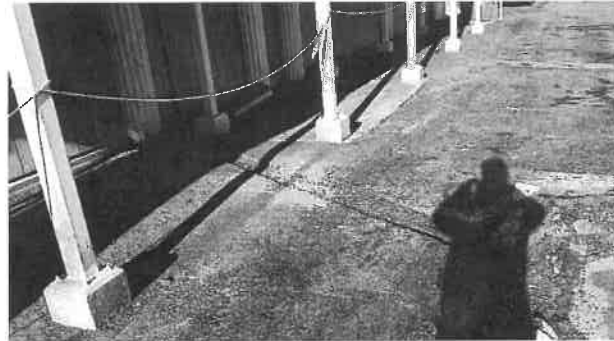
- The bituminous pavement on the north side of the west wing was cut for the installation of a new gas line for the emergency generator. The opening is a tripping hazard and should be filled and paved.

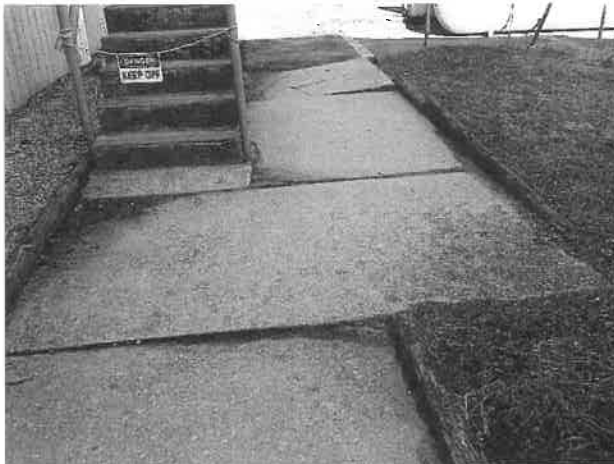
- Existing concrete sidewalk sections that are heaved and displaced should be replaced.

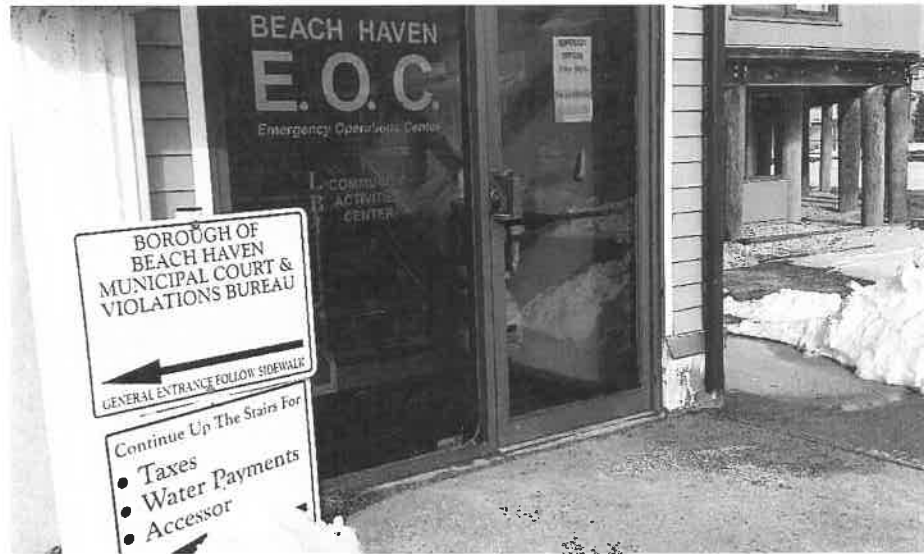
- **Roofs:** The existing roofs are in serviceable condition and are under warranty.
- **Gutters and Leaders:** Aluminum leaders (downspouts) throughout are dented and should be replaced with new prefinished aluminum leaders matching the existing size.
- **Main Entrance:** The main entrance door and storefront are single glazed, glazing gaskets are separating from the frames, and joint sealers are deteriorated. The door and storefront should be replaced for energy-efficiency. This improvement should be included as part of the elevator addition / alteration.

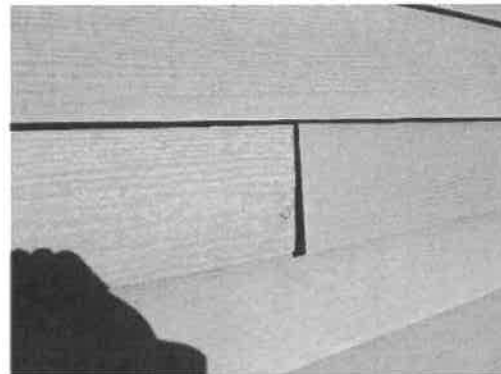
- **Wood Siding:**
  - Wood siding throughout the East Wing should be replaced where split and deteriorated and should be painted to prevent further deterioration.
  - Fiber cement clapboard siding is present at the south side of the upper level and at the east side of the West Wing. The fiber cement board is cupping and warping, butt joints not sealed, there is no sealant at the corner boards. New sealant should be installed at all butt joints and at the intersection between the fiber cement siding and the corner trim.

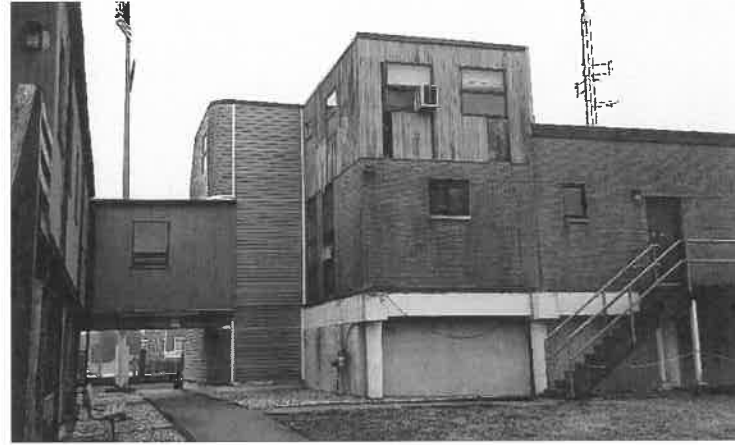
- At the northeast corner of the upper level, the vertical wood siding is significantly deteriorated, sections are missing, and building paper is also missing, leaving wall sheathing exposed to the weather. The vertical siding, building paper, and any weather damaged sheathing, should be replaced.

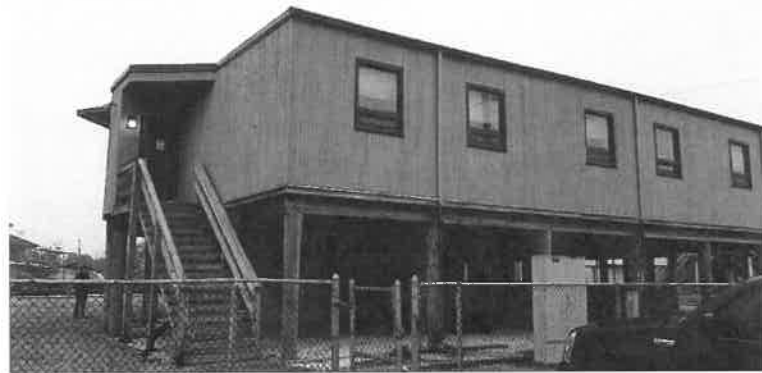
- The paint on the vertical wood siding on both wings is weathered and should be repainted. The weathering is most prevalent on the north side of the building.

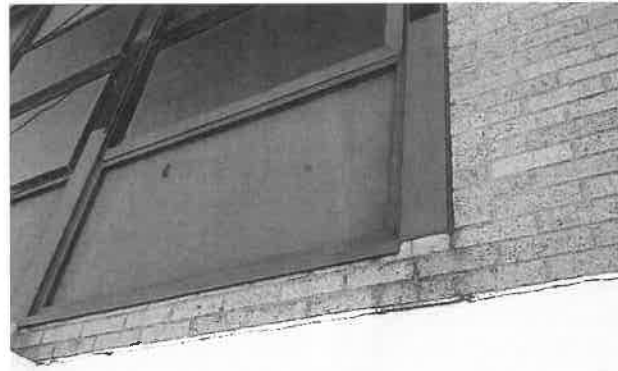
- **Joint Sealants:** Joint sealants throughout the exterior require replacement, including the perimeters of window and door frames, and joints at siding butt joints and between wood siding and corner trim boards.

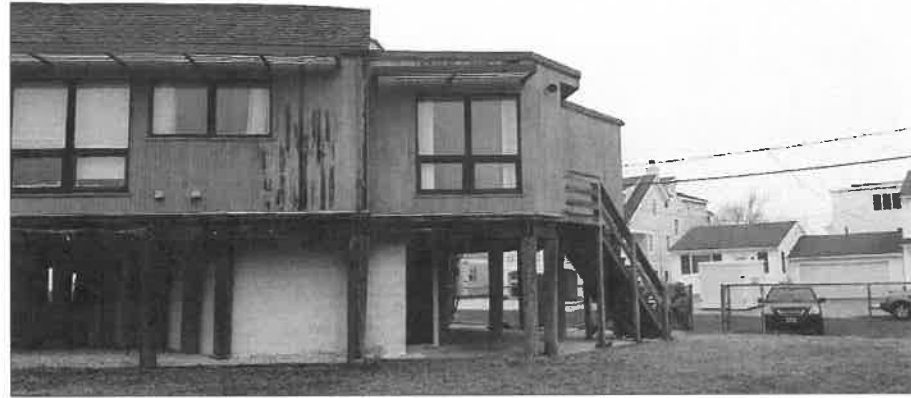
- **Lower Level Enclosure:** The gap between the lower level wood enclosure and the piles should be closed.
- **Support Structure:** The wood support structure at the East Wing should be painted to prevent deterioration.

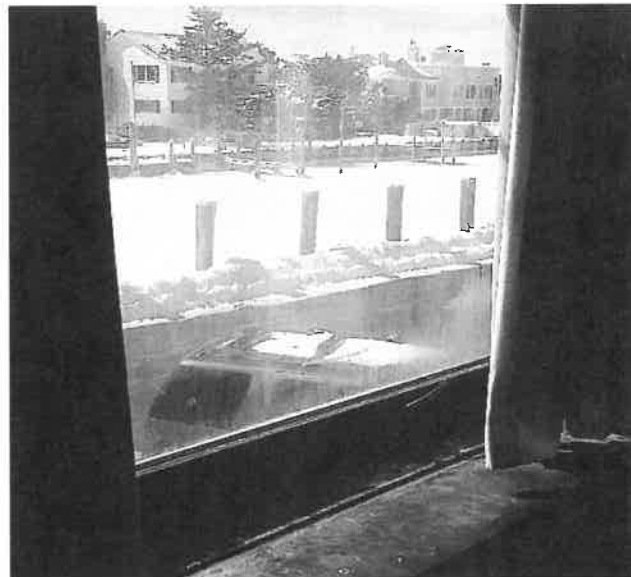
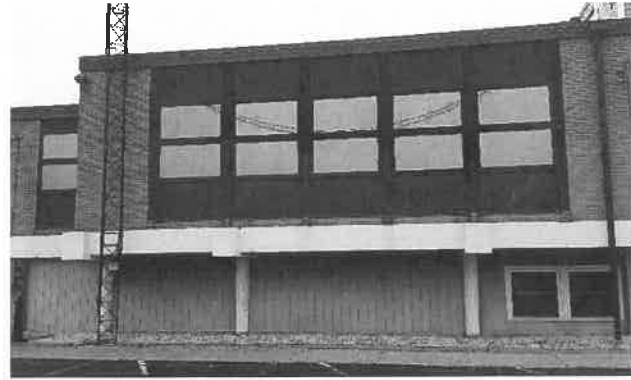
- **Windows:** The windows throughout the West Wing have broken hermetic seals and condensation stains between the insulating glass panes. Windows throughout the building have been painted over the original anodized aluminum finish at the sash, frame, and at spandrel panels. The paint is faded, weathered, and separating from the surface. Some wood sills beneath the windows are rotted and require replacement. At the upper level, two window sash have been removed to accommodate through-wall PTAC (packaged terminal air conditioning) units.

The necessary repair includes the replacement of glazing panels that have fogging damage due to loss of hermetic seal. Alternatively, for future use by the Borough, the windows throughout should be replaced with new low-emissivity, insulating glass units. Rotted wood sills should be replaced.

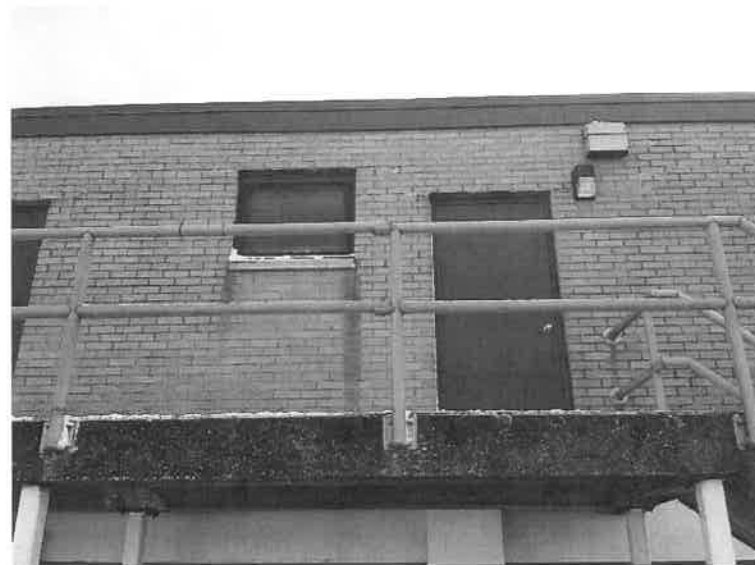
- **Lintels:** The steel lintels over the windows and doors at the West Wing are not galvanized and are deteriorated, rusting, and many are delaminating. Some lintels extend beyond the face of the brick. As these lintels delaminate they expand, cracking the brickwork and displacing the mortar joint. The result is additional water infiltration into the wall system, accelerated deterioration of the masonry wall system as a result of freeze thaw cycles, and loss of structural section on the lintels.

The lintels will need to be replaced. The brickwork above the lintel, and at bearing, will need to be removed, any construction above exposed brickwork temporarily shored, and a new lintel installed. Removed brickwork will need to be replaced with new material or salvaged brick.

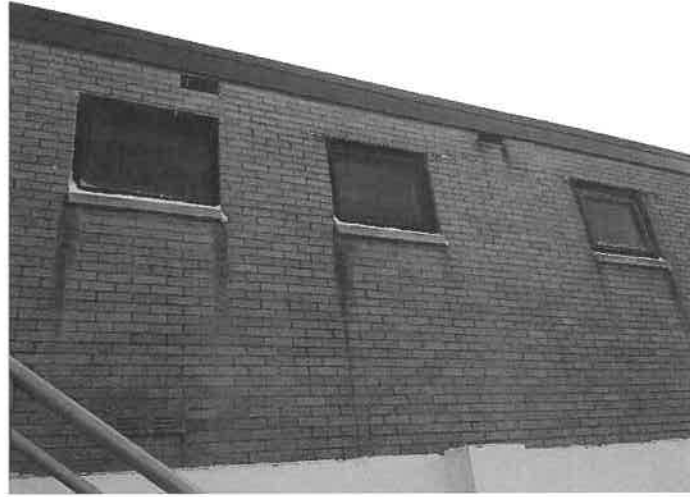
- **Exhaust Duct Openings:** Exhaust duct openings at the north side of the West Wing are open and uncovered. Weather and bird proof vent covers should be provided.

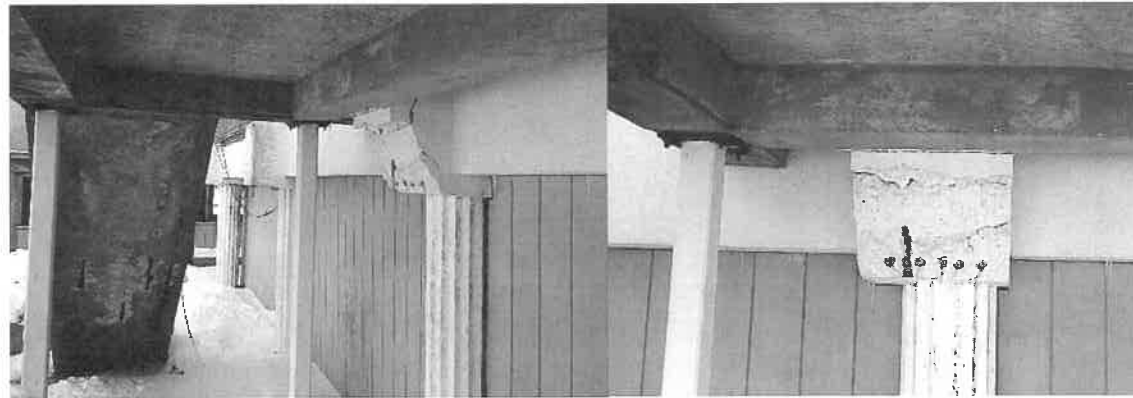
- **Concrete Beam Extensions:** The exposed extensions of reinforced cast-in-place concrete beams about the perimeter of the West Wing, are cracking and spalling, exposing the ends of steel reinforcing. The extensions should be cut back to the face of the exterior, and coated with cement plaster.

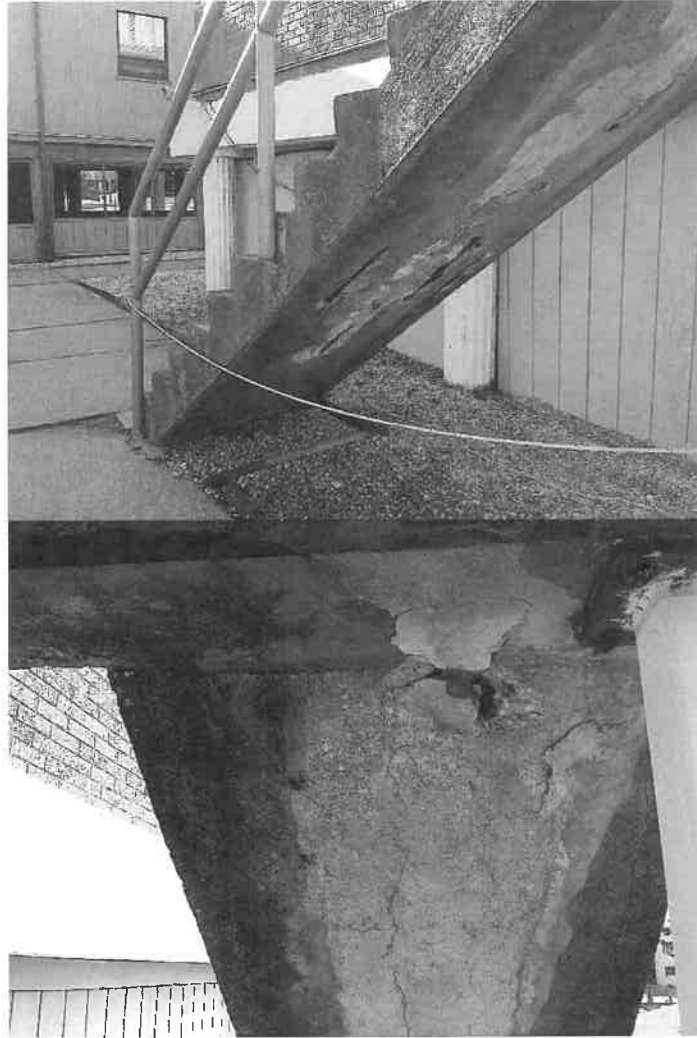
- **Concrete Stairs and Landings:** Structural evaluation recommends that the existing concrete stairs and landings on the north side and west side of the West Wing be removed and reconstructed in their entirety. The replacement stairs will be required to meet current Code requirements with respect to riser height, tread depth, and hand and guard rails. Reinforcement for exterior concrete should be epoxy coated.

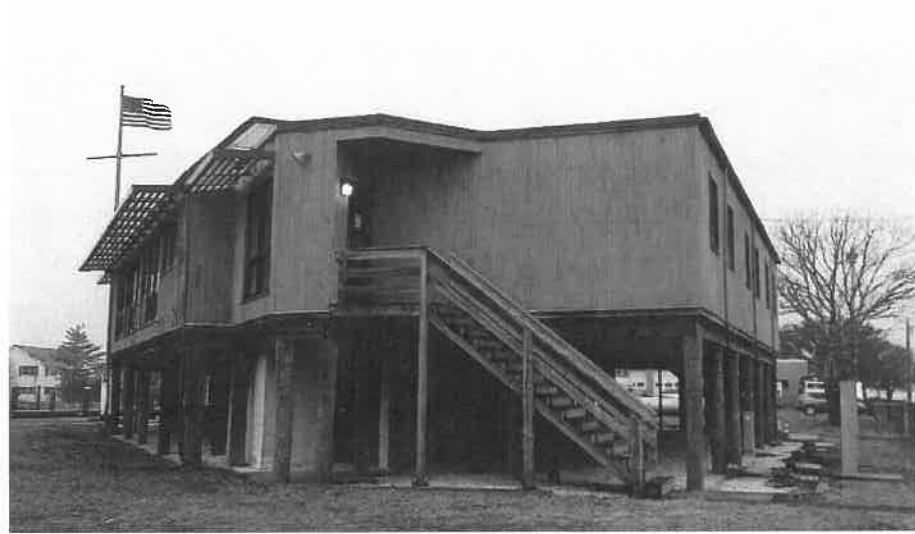
- **Wood Stairs and Landings:** Wood exit stairs are present at the east and west ends of the East Wing. The stairs are structurally sound. The stairs do not meet current code requirements with respect to tread depth or handrail configuration. There is no requirement to rehabilitate the stairs unless they are altered.

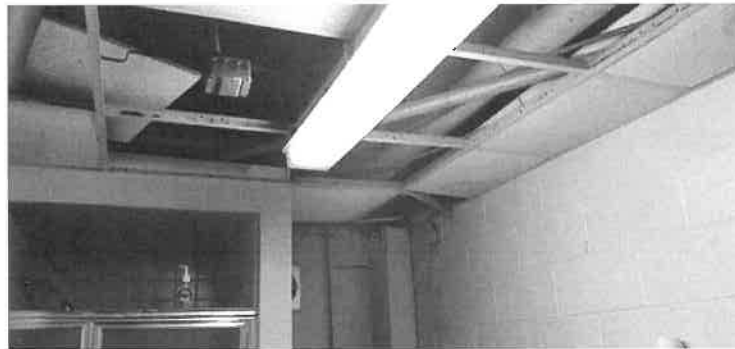
- **Ceilings:** Damaged and missing ceiling tiles should be replaced with new humidity resistant panels matching the existing finish and texture.
